NEW LAGUN BUSHINGS

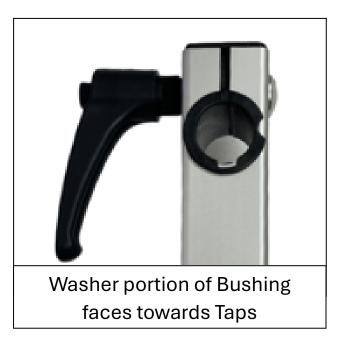
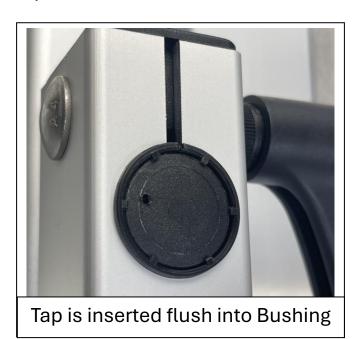
Proper assembly of the parts is essential to ensure proper function. The original Bushing style allowed the Arm to be installed upside down.

New Bushings are being implemented to include 'teeth', which will prevent the Arm from being assembled upside down.

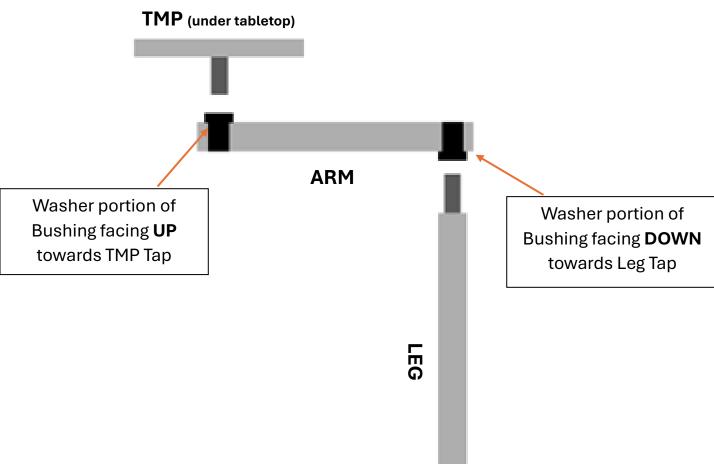
INSTALLATION EXAMPLES

ARM w/original bushing style = UPSIDE DOWN

NEW BUSHING STYLE **WILL NOT ALLOW**ARM TO BE INSTALLED UPSIDE DOWN.

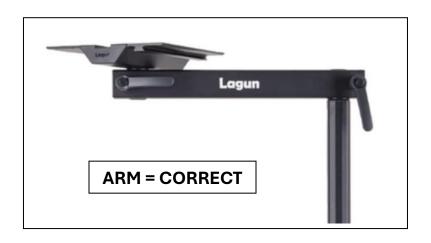
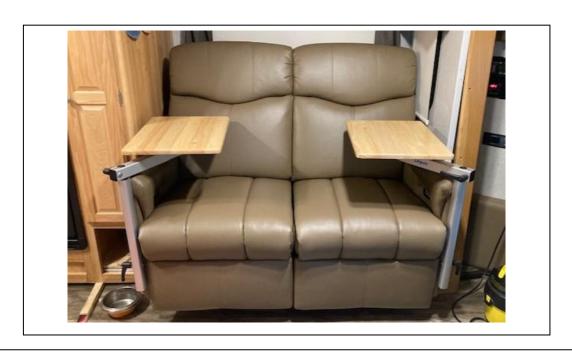
ARM ORIENTATION = BOTH CORRECT

*Notice handles facing opposite directions.
